Geotechnical Investigation of Pavement Failure: A Case Study of Sango Ota - Owode Expressway, Nigeria

Akanbi DO^{1*}, Mlanga VT², Ekpo E², Egbo GN¹

¹Nigerian Building and Road Research Institute, Artisan Training and Pozzolana Centre, Bokkos, Plateau State, Nigeria

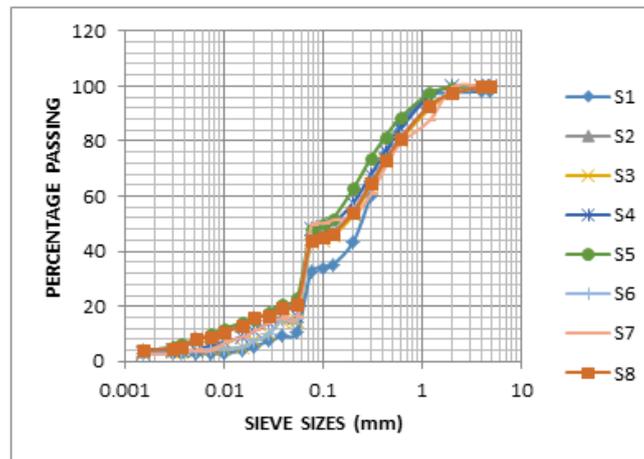
Fig-1: Graph showing the sieve analysis of the sub grade soil samples in the bad sections

Figures 1 and 2, shows the Particle Size Distribution of the bad soil samples at Subgrade and Subbase respectively with percentage passing plotted against sieve sizes. Sango Ota- Owode lane is represented by (S-O), while Owode – Sango Ota lane is represented by (O-S). The results shows that the particle size distribution classified the subgrade samples for locations at Sango (Km 1 + 345(s-o)), Iyana Joju (kM 2 + 050 (s-o)), Oju ore (kM 28+ 100 (o-s)), Honda (kM 25+ 069(o-s)), Iyana Iyesi (Km 24 + 000 (o-s)), Igboloye (Km 19 + 300 (o-s)), Atan (kM 20 + 150 (s-o)) and Owode (Km 31 +100 (s-o)) as A-2-4, A-2-6,

A-2-6, A-2-7, A-2-7, A-2-7, A-2-6 and A-2-7, respectively based on AASHTO soil classification scheme, and Sc, Sm, Sc, Sc, Sc, Cl, Sm and Cl, correspondingly based on the Unified Soil Classification System (USCS). The Percentage passing sieve No.200 for all subgrade samples except sample 1, collected at Km 1+345 are greater than 35%, implying that they are poor materials. The subgrade samples cannot therefore, be recommended for new repairs. As a result, they need to be completely removed and replaced with better materials for construction. Also, a strong stabilization material may be applied in the subgrade soils to improve their performance.

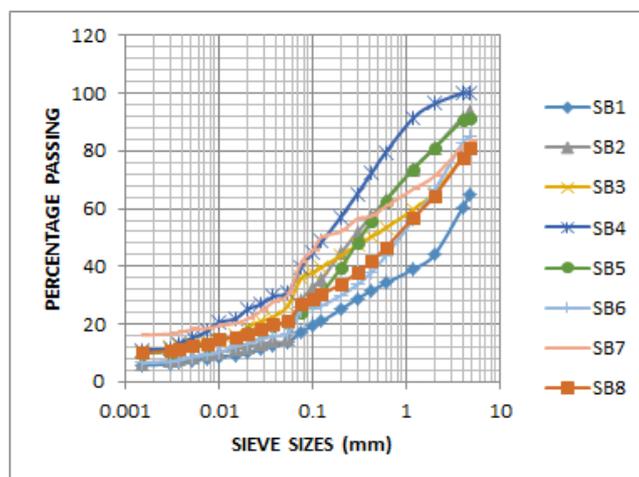
Fig-2: Graph showing the sieve analysis of the sub base soil samples in the bad sections

Similarly, the particle size distribution results for the subbase samples for locations at Sango (Km 1 + 345(s-o)), Iyana Joju (kM 2 + 050 (s-o)), Oju ore (kM 28+ 100 (o-s)), Honda (kM 25+ 069(o-s)), Iyana Iyesi (Km 24 + 000 (o-s)), Igboloye (Km 19 + 300 (o-s)), Atan (kM 20 + 150 (s-o)) and Owode (Km 31 +100 (s-o)) are classified as A-2-6, A-2-7, A-2-7, A-7-5, A-2-7, A-2-6, A-2-7 and A-2-6, respectively based on AASHTO classification scheme and Sm, Sm, Sm, Sm,

Sm, Sc, Sm and Sm, correspondingly based on the Unified Soil Classification System (USCS). The Percentage passing sieve No.200 for all subbase samples except samples 3, 4 and 7, which are 35.87%, 39.74% and 41.31%, respectively, are less than 35% specified for percentage passing sieve No. 200, implying that the samples at these locations need to be removed and replaced or stabilized with a strong additive.

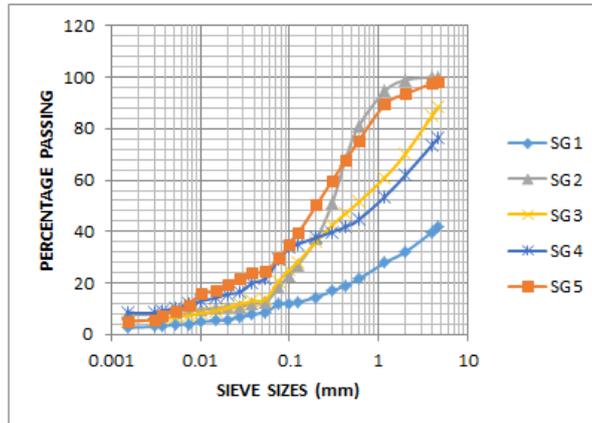
Fig-3: Graph showing the sieve analysis of the sub grade soil samples in the good sections

The results of the soil classification at the good sections shows that subgrade soil samples at Oja ota(Km 6+200(S-O)), Covenant(Km 10+025(S-O)), Iju(Km 12+150(S-O)), Ajibawo(Km 23+000(O-S)) and Idedo(Km 26+100(O-S)) are classified as A-2-4, A-2-4, A-2-6, A-2-4, A-2-6, respectively based on AASHTO

soil classification scheme and Sc, Sc, Sm, Sc and Sm correspondingly based on the unified soil classification system (USCS). The percentage passing sieve No.200 for all the subgrade are less than 35% implying that they are good materials.

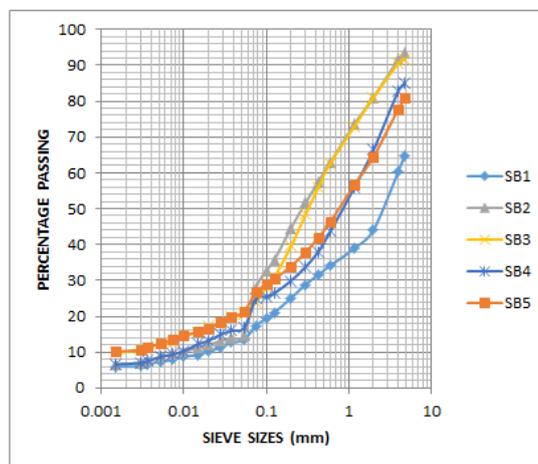
Fig-4: Graph showing the sieve analysis of the sub base soil samples in the good sections

Similarly, the subbase soil samples are classified as A-2-7, A-2-4, A-2-4, A-2-6 and A-2-7 respectively, based on AASHTO classification scheme and Sm, Sc, Sc, Sm and Sm, correspondingly based on the unified soil classification system (USCS). The percentage passing sieve No.200 for all the subbase samples are satisfactory as none is greater than 35%

passing.

In relation of the good sections to the failed sections on the pavement, it can be seen that all the samples collected from the stable section met their respective criteria and are therefore good materials. Hence, the reason for their stability.
