Analysis of Material Failure Due to Rigidity Changes on a Motorcycle Frame Body Structure

Keywords: Frame, Low Torque, Trellis, HAZ, Failure.

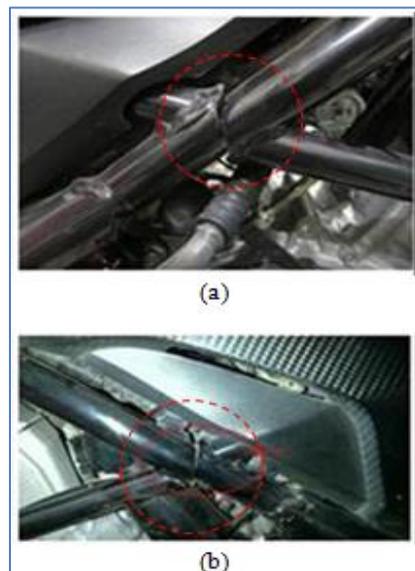
Furthermore, from every cases that occur, only similar cases are studied and analyzed in this study. The main problem in this case is that customer complain that the condition of the right and left body frames is

broken, which can be seen in Fig. 3. The motorcycles that experienced this case have traveled an average of 10,000 km, which is read on the odometer.

Fig-3: Broken frame body (a) Pipe Comp L, (b) Pipe Comp R

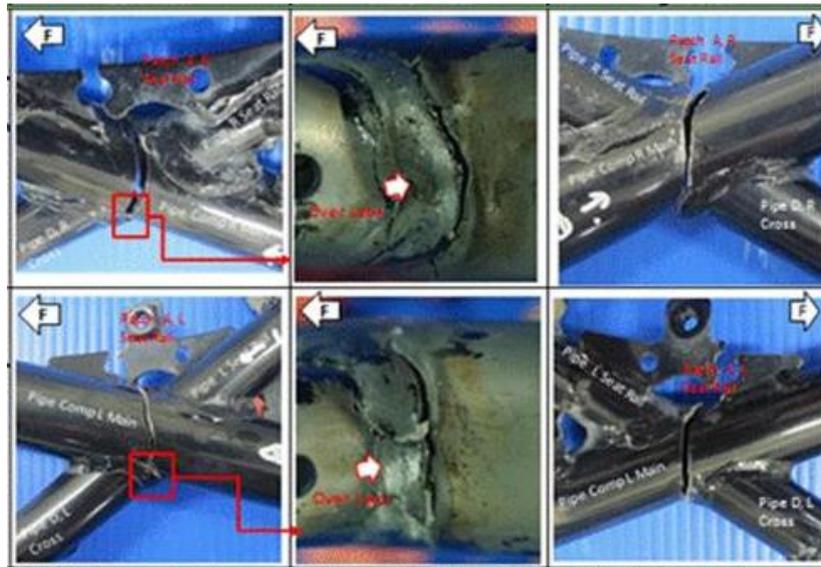
From the results of the analysis it was found that the fracture in the frame body occurred at the edge of the weld on the pipe comp R/L which can be seen in Fig. 6.

Fig-6: The results of the analysis of the frame body fracture

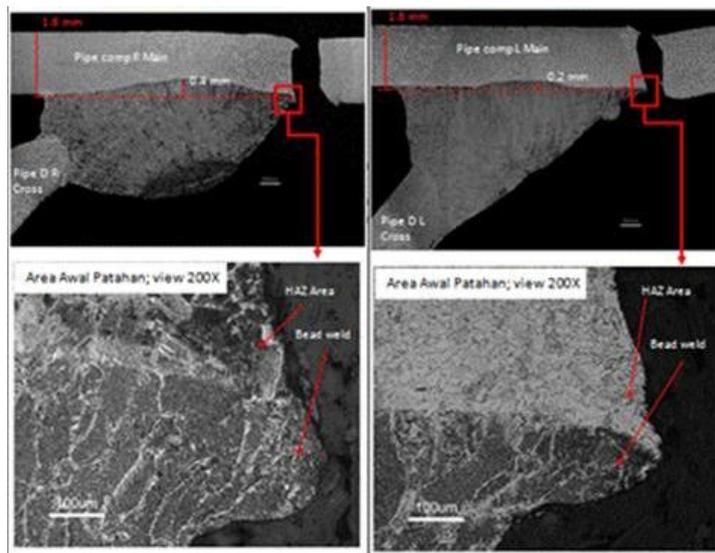
Material analysis is carried out to determine whether there is a deviation in material properties or not. The results of the SEM show that the failure that occurs is a fatigue failure and the area of the fracture at

the end of the welding bead is in the HAZ (Heat Affected Zone) area, which is the most critical area of the welding area [6]. There was also no undercut crack in this fault as the initial cause of the fracture. The results of the SEM can be seen in Fig. 7.

Fig-7: SEM Results

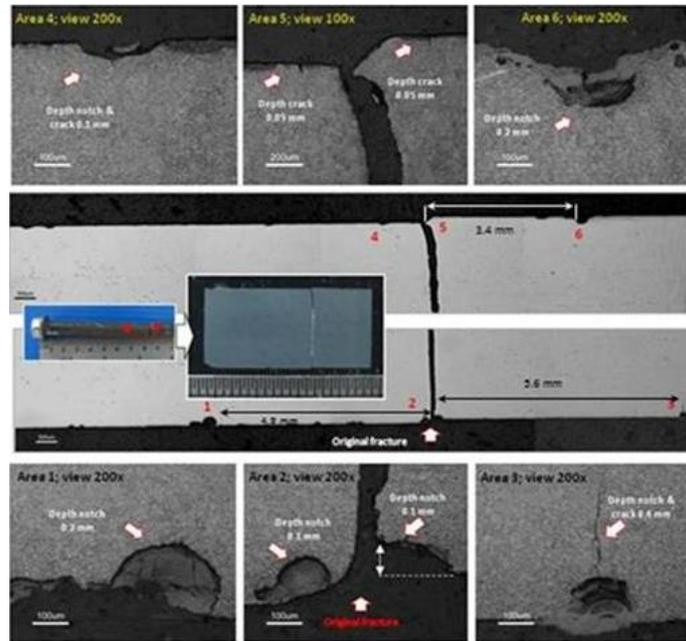
Fig-8: Microstructure test results on failed bolt flange 10x250

The results of the microstructural analysis on the failed bolt flange 10x250 showed that in the initial area of the fault there was a notch with a depth of 0.1 mm which can be seen in Fig. 8.

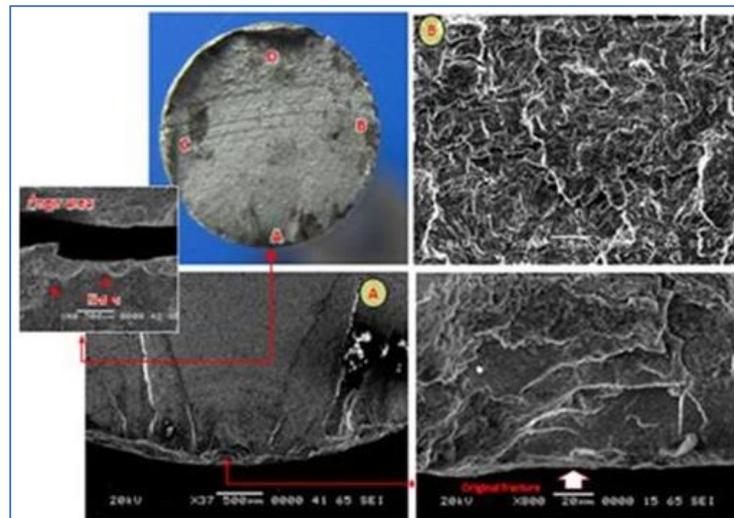
The results of the analysis using SEM can be seen in Fig.9, which shows that the fracture starts from the notch area (area A), then moves slowly upwards, and the fracture pattern that occurs is a fatigue fracture pattern.

Fig-9: SEM analysis results on failed bolt flange 10x250

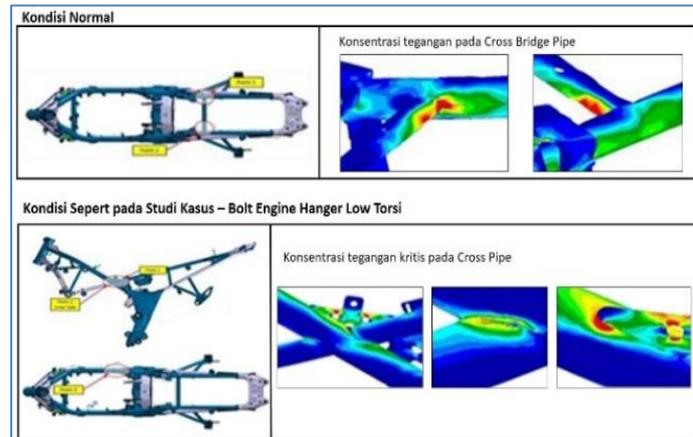
The results of the CAE simulation on the models that have been made show that the frame body has failed due to a 10x250 bolt flange whose torque value is below the standard (low torque). The

comparison between the CAE frame body simulation results in normal conditions and low torque conditions can be seen in Fig. 12.

Fig-12: Comparison result for CAE simulation of normal bolt flange 10x250 with low torque

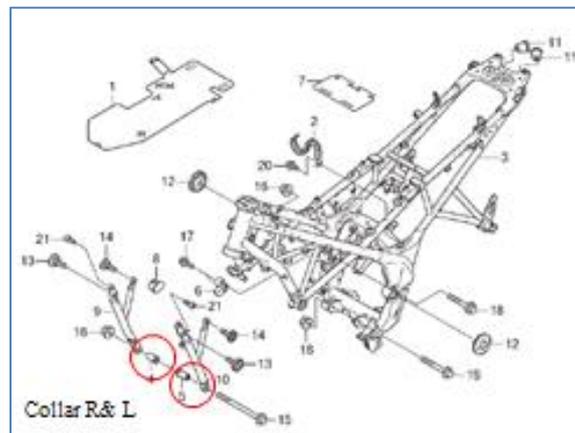
Conclusion is the stress number increasing 5,7 time from standard specification when pass through the bad road. From CAE simulation shows that critical area on the crack area and the simulation carried out for the modified condition from customer to see the effect of installation of R & L collar to torque which can be seen in Fig. 13.

Fig-13: R & L Collar position at motorcycle frame

From the simulation of R & L collar installation shows us that installed backwards and the torque is bigger than normal or standard.

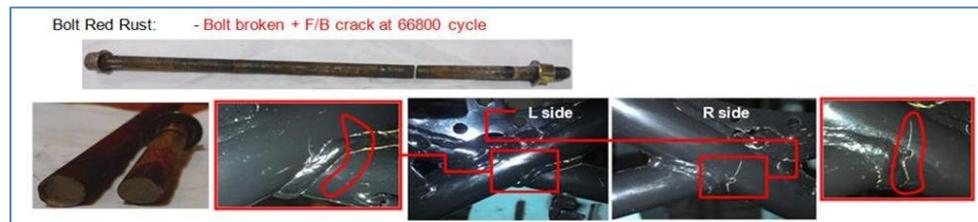
The results of the durability test showed that the 10x250 bolt flange that was broken after the durability test was the same as the one found on customer motorcycles. This can be seen in Fig. 14.

Fig-14: The results of the 10x250 bolt flange fracture and the frame body after the durability test

Based on the results of simulations and analysis that have been carried out on the frame body and bolt flange 10x250, failure is caused by the bolt flange 10x250 being installed on the frame body with a torque value below the standard (low torque), which results in structural failure and the bolt flange itself [7]. This is due to indications of modifications to the bolt flange made by customer.

The low torque 10x250 bolt flange causes excessive vibration in the bolt flange and frame body. With this vibration, the level of rigidity or rigidity of the structure on the frame body also decreases. So a critical point arises in the weakest part of the frame body, namely the welding section, which is included in the HAZ section. For a long time, this condition and the load received continuously and repeatedly cause fatigue failure of the frame body and the bolt flange 10x250.

The advice that can be given based on the results of the research that has been done above is to pay more attention to the torque value on the 10x250 bolt flange on the engine hanger. If a bolt is found in a state of below standard torque, it must be tightened immediately by following the instructions in the Owner's Manual, or it can be taken directly to the nearest authorized workshop for service if an indication of a loose bolt flange is found.
