# Common Defects, Causes, and Impacts in High-Altitude Stone Masonry Construction: A Case Study of Jumla, Nepal

## Abstract

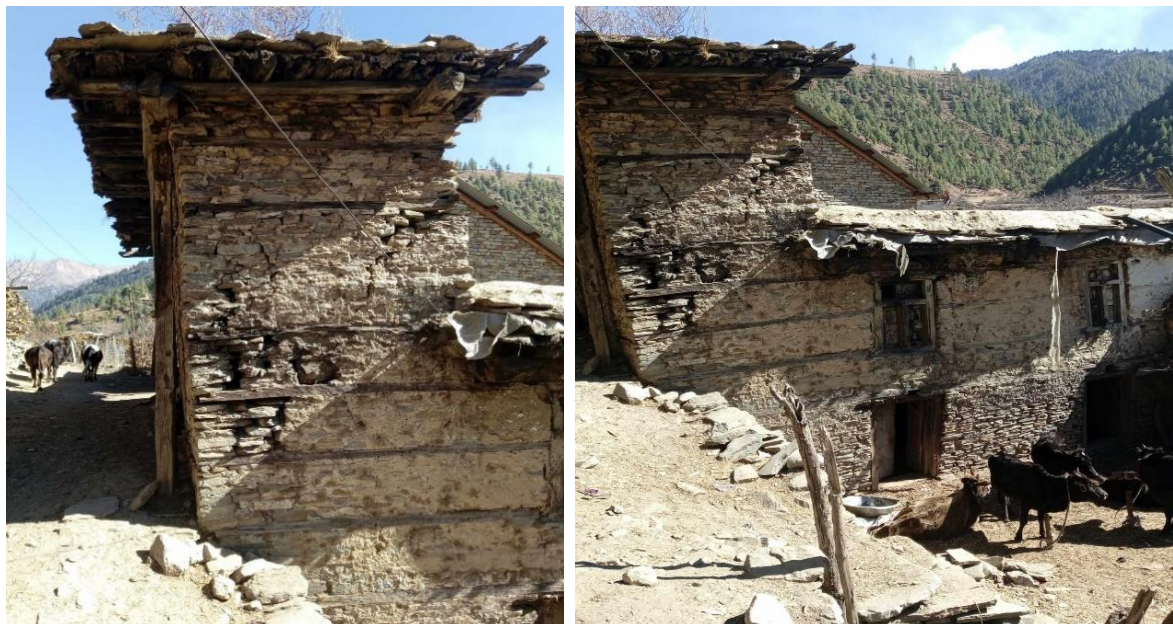
**Picture 1: The common and repeated construction defects cracking on wall is seen. The wall may collapse due to uneven settlement from the foundation**

**Field Observation Evidence:** Picture 1 shows wall cracking resulting from uneven foundation settlement. The crack pattern suggests differential movement, with widening at the top indicating ongoing settlement.

1. **Improve Foundation Construction:** Focus on proper foundation depth, leveling, and compaction to prevent settlement issues (Ali *et al.*, 2013; Varum *et al.*, 2018).

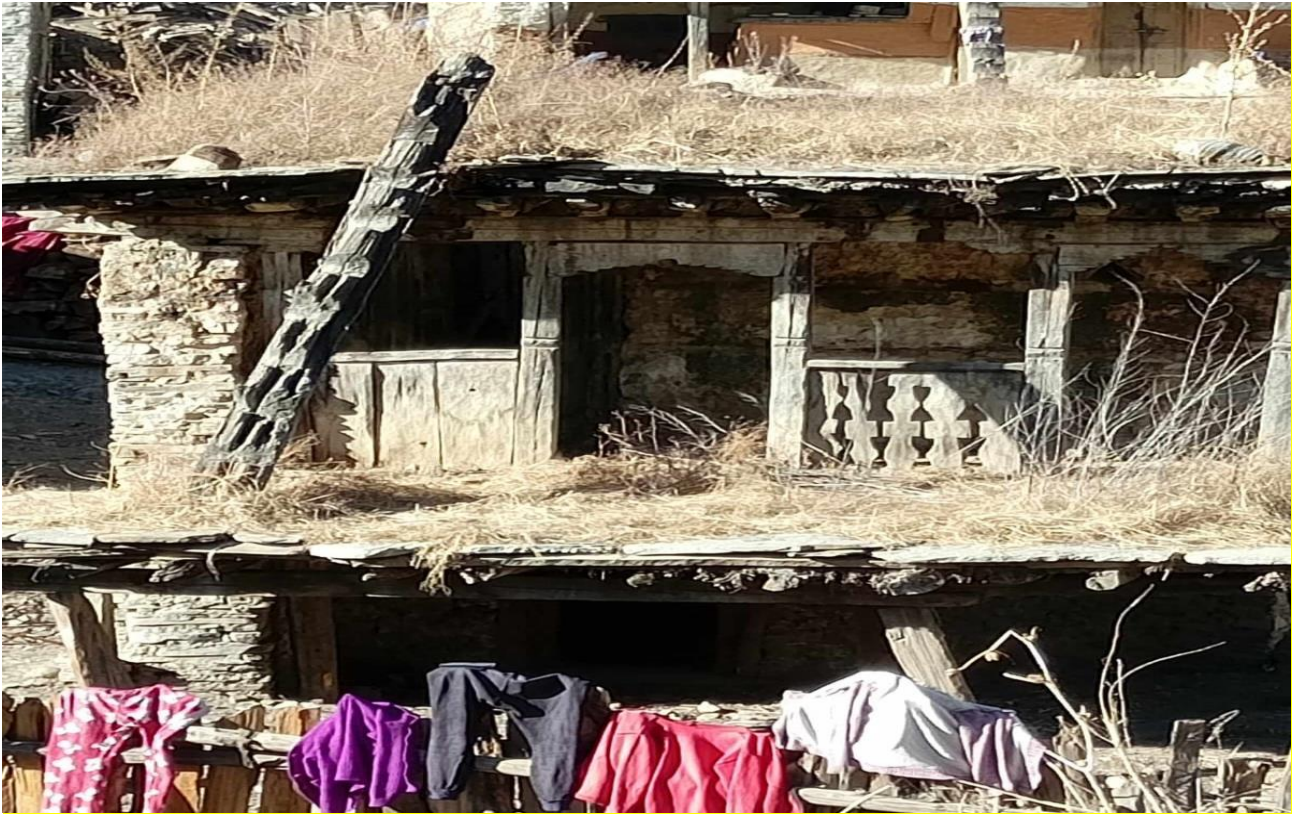
**Picture 2: Due to settlement issues the level of window, door fall down from their original level**

**Field Observation Evidence:** Picture 2 demonstrates how settlement caused door and window frames to fall below their original levels, rendering them inoperable.

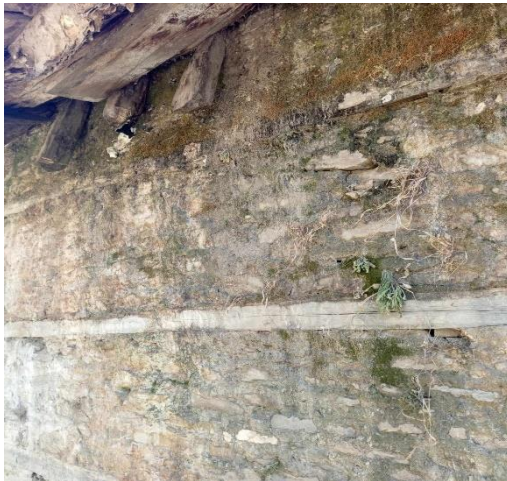
Mud plaster deterioration was common on wall surfaces, particularly on exposed exterior walls. The

plaster showed signs of weathering, with flaking, cracking, and partial detachment from the underlying masonry.

**Picture 3: Mud plaster fall down & weathering effect is seen at wall surface**

**Field Observation Evidence:** Picture 3 shows mud plaster fall-down and weathering effects on wall surfaces, revealing the underlying stone masonry.
