# Deterioration and Failure Rates of Maintained Roads in Nigeria

This study evaluated failure rates of roads maintained by FERMA in Delta state and its effects. The three roads investigated are: Benin-Asaba dual carriage way (266km), Warri-Sapele-Benin dual carriage way and Asaba -Allah-Ebu Edo state border road(47km). Road condition survey was carried out on the three roads to ascertain the extent of deterioration. Sieve analysis, liquid limit, compaction and CBR tests were conducted on the material used for the maintenance works for quality control purpose. Liquid limit, optimum moisture content, unsoaked CBR values were 21%, 8.5% and 117% respectively. These were observed to be within the FMW highway manual guidelines. It was observed that beyond 12months, Benin-Asaba and Warri-Benin roads experienced 2% and 5% failure rates while Asaba-Illah recorded 30% failure rate within a 12month period. These failures were attributed to heavy traffic with heavy duty wheel. Challenges of road maintenance in the field and remedial measures for highway maintenance is also discussed. The authors recommend that FERMA should seek redress and go back to the establishing blue print for operations

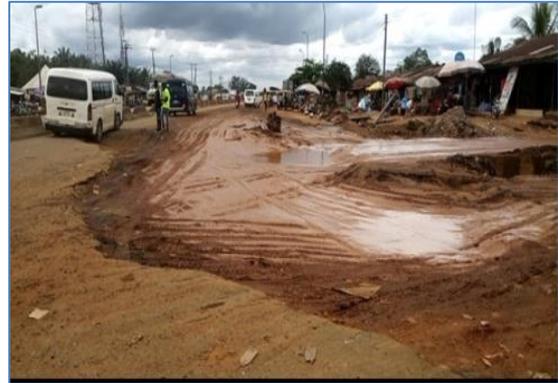
Fig-2: Condition of Benin Asaba road

The Benin -Asaba road as shown in Fig. 2 has deteriorated to be point where the subgrade soil is now visible owing to the heavy traffic that ply this route. On the Warri - Sapele - Benin dual carriageway, there are so many defects on this road because of the frequent heavy axial load passes that have resulted in fatigue of the pavement. This has manifested in alligator cracks, isolated potholes, failed sections and undulations on the pavement. The intense raining season has led to the development of potholes and some sections of the carriageway have collapsed resulting in serious traffic

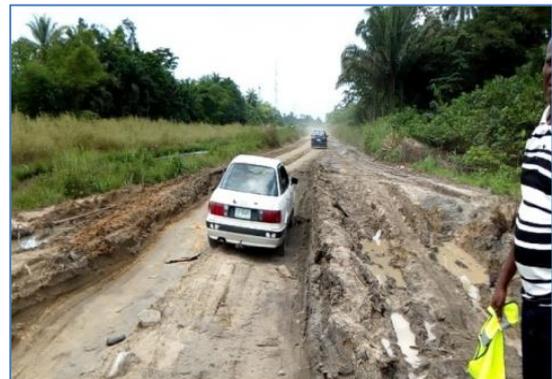
Fig-3: Condition of Warri-Sapele road

This is one of the most important federal roads in Delta State because of its strategic location. It is heavily trafficked and there are so many defects on this road because of the frequent heavy axial load that ply it resulting in fatigue of the pavement. This has manifested in alligator cracks, isolated potholes, failed sections and undulations on the pavement.

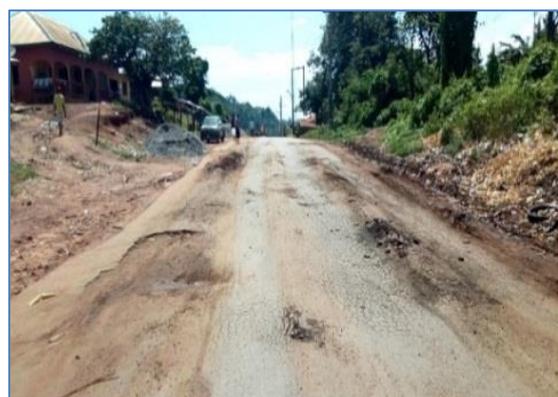
Fig-4: Condition of Asaba – Illah – Ebu Edo

gridlock on both bounds of the road. The Asaba-Allah road serves for easy evacuation of farm produce from the communities along the road corridor to Asaba and other cities. Since the commissioning of Utor Bridge at the border of Edo state and Delta State in 2014, there has been tremendous increase in traffic on this route, and this resulted in the sudden collapse of the carriageway.

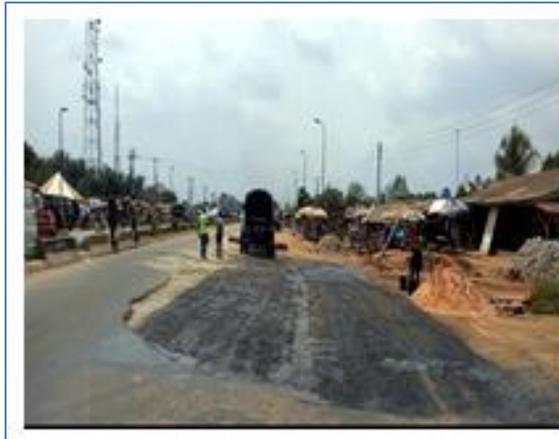
**Fig-7: Priming of Benin-Asaba road road**

On the work progress on the roads, Figures 7-9 below gives details on the Benin -Asaba, Warri-Sapele-Benin and Asaba – Illah – Ebu Edo State border roads.

The Prime coat was applied at an average spray rate of 1.083litres/m<sup>2</sup>. The insitu-density of the soil and stone base was determined by sand replacement method.
