An Integrated Approach for Structural Crack Monitoring: Combining Plastic Tell Tales and Image Analysis for Enhanced Structural Health Evaluation

Data collection focused on cracks present in different parts of the Al-Beruni Block, specifically in the columns, beams, and slabs. A total of 13 cracks were identified across various laboratories within the university, including:

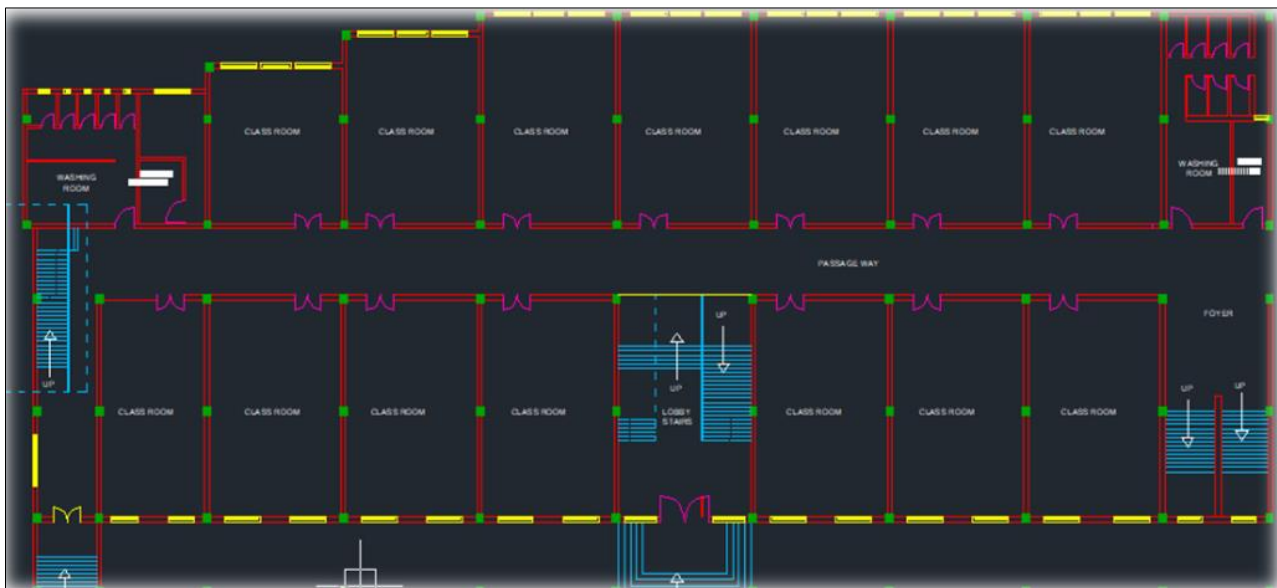
Fig. 3: Ground floor plan

Ground floor plan shows the arrangement of the walls and the rooms, as well as the columns and beams, on the building's main level. The figure correlates the observed crack locations with structural features. We compare the ground floor plan with the basement plan and can tell from this if the cracks seen in the basement run up to continue to destabilize the goods above. This level is particularly important to analyze cracks since the cracks are subjected to more wear and tear from human traffic and environmental exposure as well as significant dynamic loads on this floor.

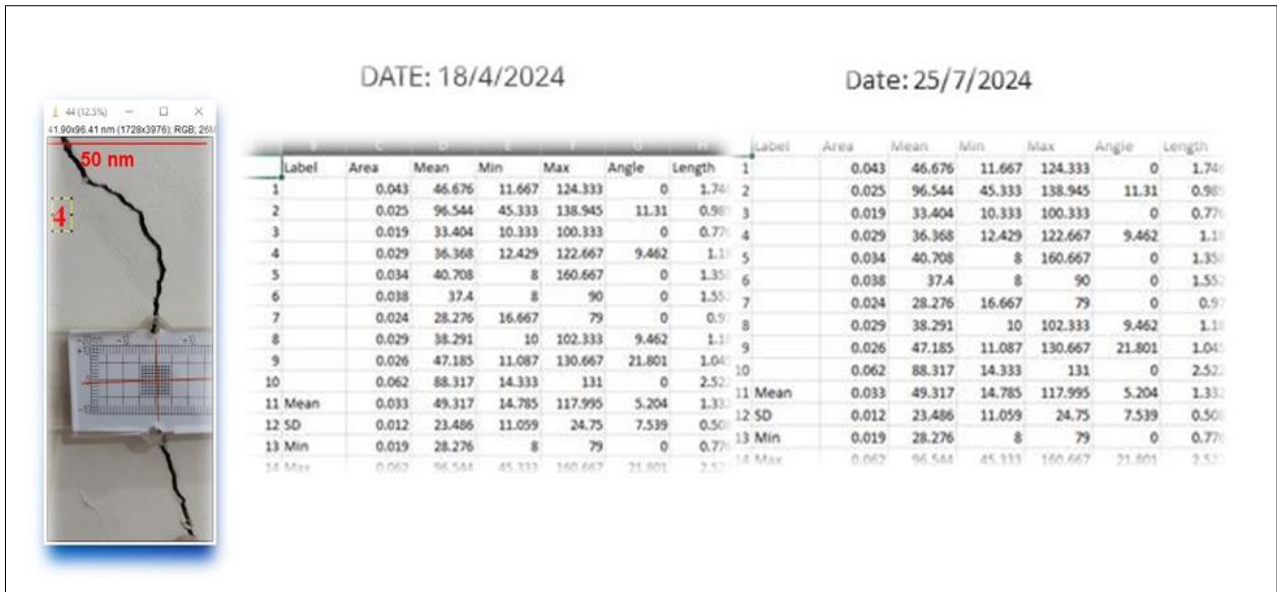
Fig. 8: CRACK 5

The progression of Crack 5 was recorded, noting widening during heat cycles. The results suggest thermal expansion and compaction are at play. Bands of thermal insulation and sealing should be applied to affected areas, as far as practical, to minimize effects on temperature on structural stability.

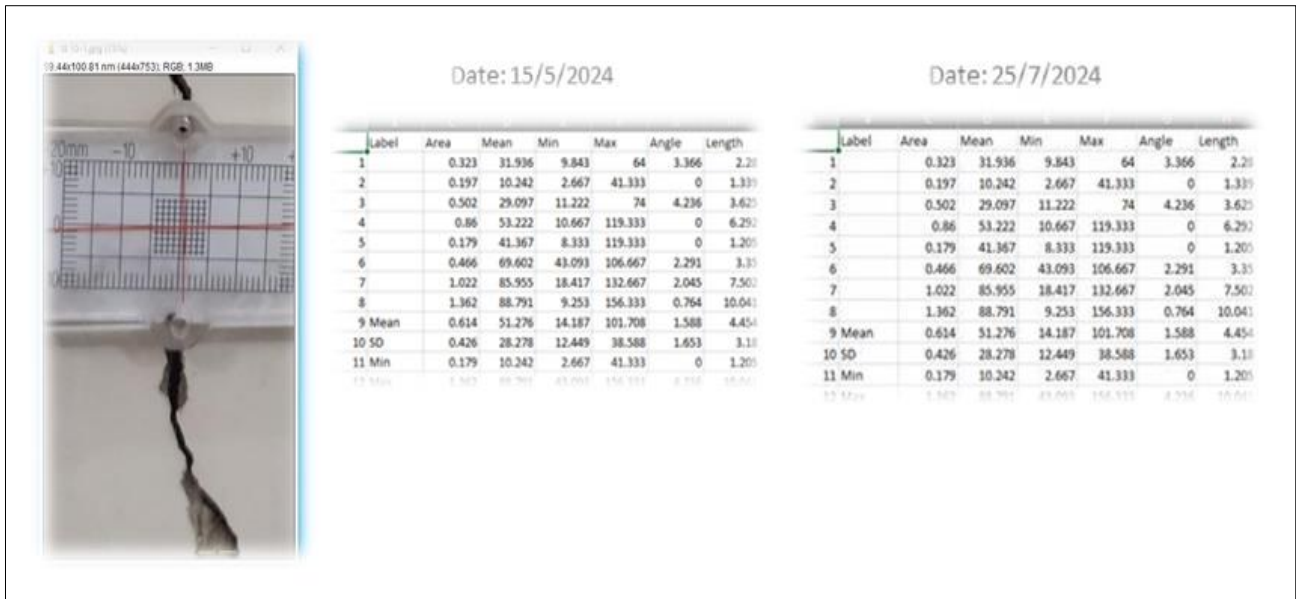
Fig. 16: CRACK 13

Vibrations and pressure changes in fluid systems of the lab caused noticeable progress in Crack 13. It is apparent from this data that this part of the structure is under significant stress and corrective action must be taken now. There should be vibration isolation systems as well as reinforcement.

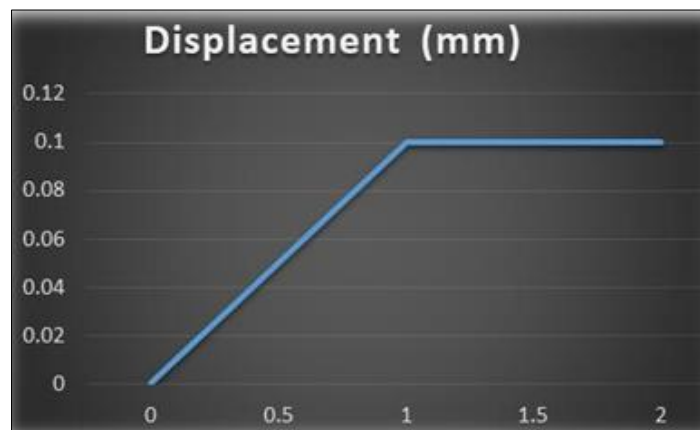
Fig. 17: Displacement time graph

This graph shows how the displacement in mm per time (in years) changes for a specific crack or group of cracks in a building. The graph shows us the displacement, to be the widening of the crack, on the y axis, and the time on the x axis.

A horizontal line on the graph indicates that the crack is stable and has not widened during the time that was observed. Such that the crack is not presently experiencing a progression, which could indicate that the structural stability in that area is also being maintained.

This is shown by a sloping line, which means that the crack is growing with time. The slope of the line in Graph is gradual, indicating that the crack is opening at a fairly slow, but also fairly constant rate. That may suggest that you should monitor it regularly, but it doesn't mean it's an immediate threat.
