The Influence of Dental Implant Thread Geometry on Failure Modes and Fracture Behavior

Keywords: Dental Implants; Thread Shapes; Failure Mode; SEM.

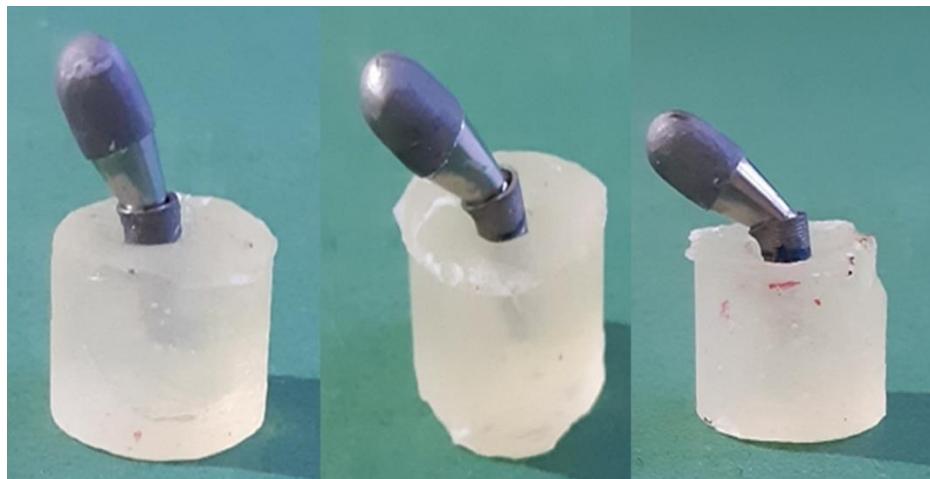
Figure 1: Deformation of dental implant specimens.

The results of the mechanical tests were analyzed using macrofracture mode analysis to determine the various fracture modes present in each specimen. In the majority of cases, the failure mechanism was almost similar, including persistent deformations of the framework in the implant neck region. The main modes of failure were fracture and deformation. (Figure 1-7)

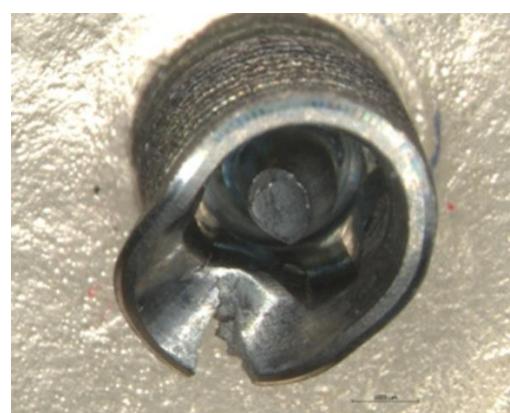
Figure 3: Fixture and screw fracture failure mode revealed by Stereomicroscope (magnification 1000 μ m), (top view).

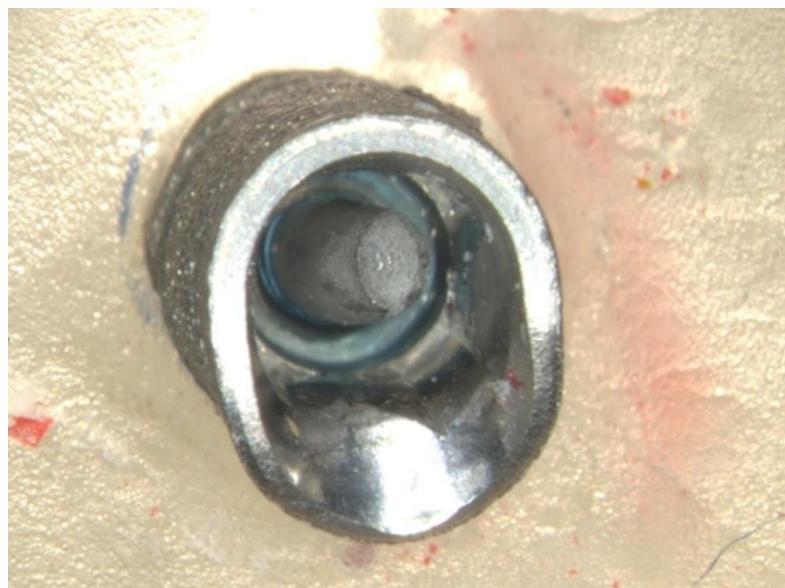
Figure 5: Screw fracture failure mode with fixture neck deformation revealed by Stereomicroscope (magnification 1000 μm), (top view).
