Analysis of Material Failure Due to Rigidity Changes on a Motorcycle Frame Body Structure

Keywords: Frame, Low Torque, Trellis, HAZ, Failure.

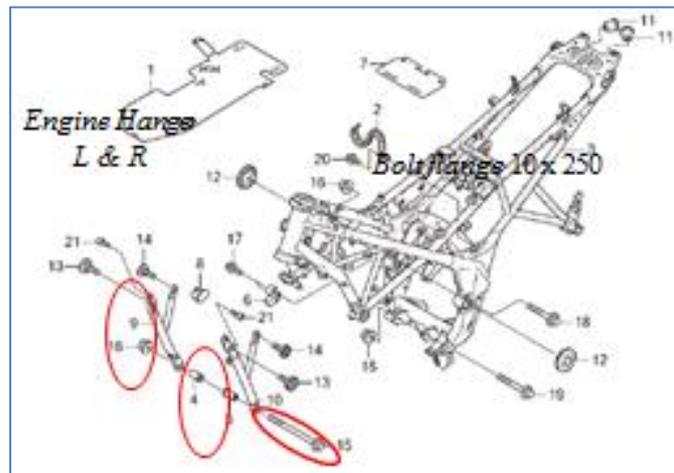
Fig-4: Engine Hanger & Bolt flange 10 x 250

This 10 x 250 bolt flange needs to be analyzed because it functions as a connector between the left side to the right side of the frame body and holds the engine in the middle of the frame, as shown in Fig. 4. So it is necessary to analyze whether there is a deviation in the bolt flange or not which can cause a fracture or not on the frame body. The analysis to be carried out is as follows:

The engine hanger pipe needs to be analyzed because it is a connector between the frame body and the engine, and when installed it will acting as reinforcing structure for the frame body, which can be seen in Fig. 4. The engine hanger pipe will be compared in terms of dimensional tolerance with standard parts that are OK.

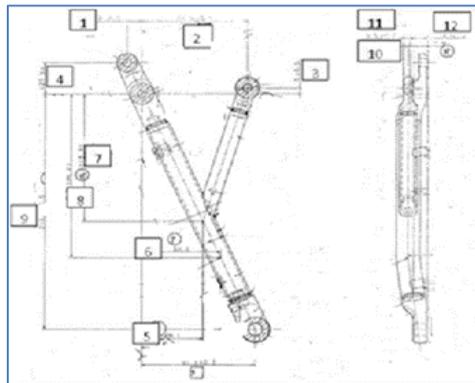
Fig-10: Drawing engine hanger

The engine hanger used in this study can be illustrated as shown in Fig. 10. To find out whether the condition of the failed engine hanger is deformed or not, a comparison is made between the failed engine hanger, standard, and OK.

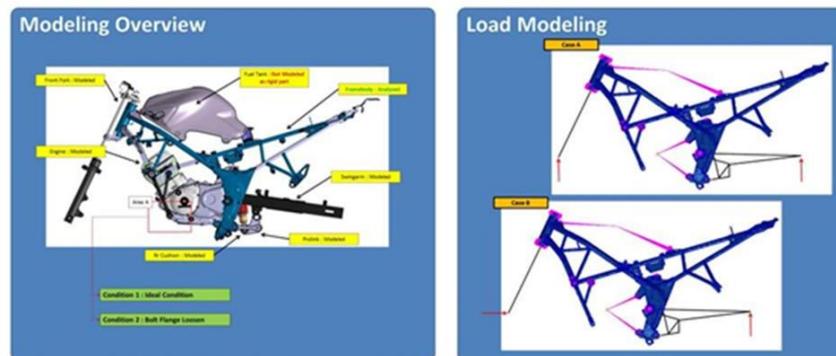
Fig-11: Modeling overview

The re-appear test is done by making a model of the broken frame body to see if the frame body here acts as a cause or effect. Therefore, CAE simulation and calculation of stress value or actual stress are carried out. In general, the modeling carried out by applying a force load to the frame body structure can be seen in Fig. 11.

The results of the CAE simulation on the models that have been made show that the frame body has failed due to a 10x250 bolt flange whose torque value is below the standard (low torque). The
