A Case Study on Irregularities Present in Tall Building and Review of Provisions on Indian Standard

Abstract

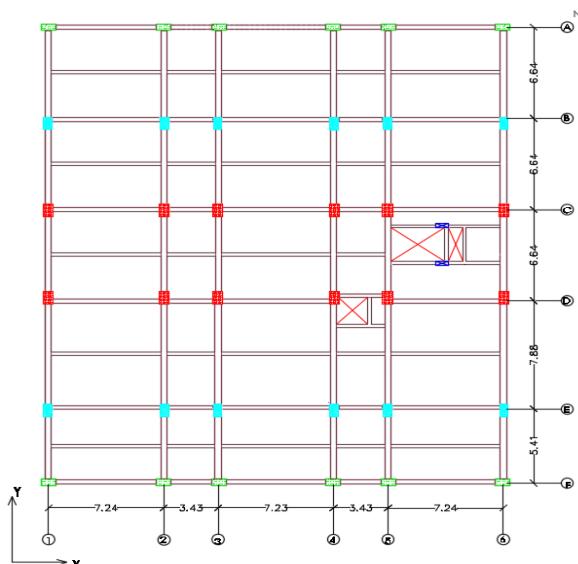
Fig-1: Beam layout of Commercial and Parking floor

One of the parking floors was maintained at 3.96m so that it would be easy for parking and all the other floors are 3.05m. Residential floors are planned to maintain proper ventilation and lighting inside the room. Beam layouts of commercial and parking floors are identical whereas changed for residential floors. Dead loads and live loads on each floor are considered as per as per IS 875 (Part 1) and IS 875 (Part 2). The building was analyzed for earthquake loads for the load combinations as per IS 456: 2000. Beam layouts of commercial parking and residential floors are as shown in Fig 1 and 2. And the three dimensional rendered view of the building is shown in Fig-3.

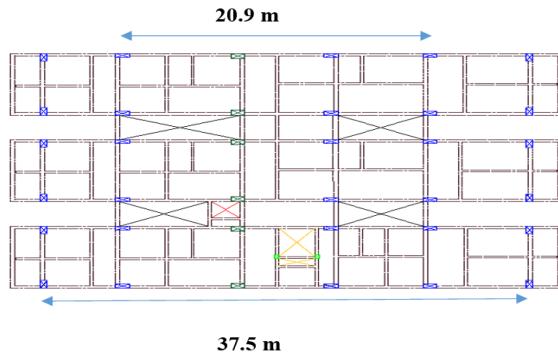
Fig-4: Beam layout of building with dimension for a re-entrant corner

The re-entrant corner is said to exist if a projection of size greater than 15 % of its overall plan dimension in that direction [1, 2].

From Fig-4 projection of 20.9m is observed for a span of 37.5m.

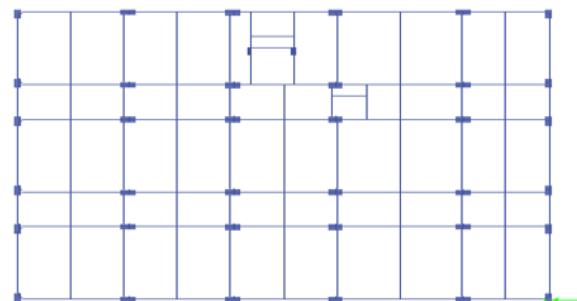
Fig-6: Layout with Lateral force system.

Irregularity is said to exist if all the structural systems resisting lateral forces are not oriented along two principal orthogonal axes in the plan. As shown in Fig-5. All the lateral load resisting elements i.e. Columns are oriented in two principal orthogonal directions in the building considered as shown in Fig-6. So the irregularity is not present in the building considered.

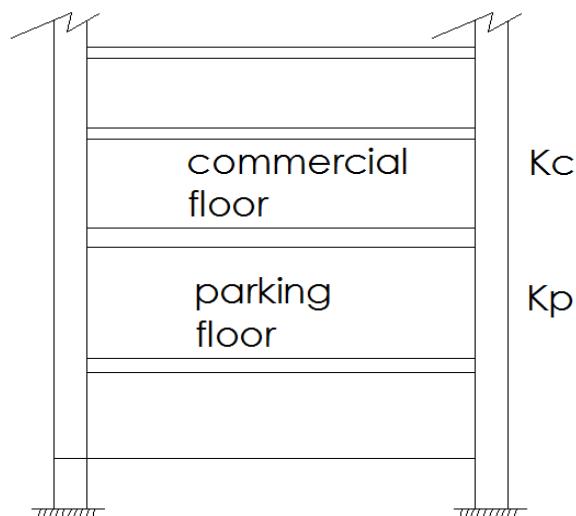
Fig-7: Section of elevation indicating different types of floors

Stiffness irregularity is checked for three different floor levels as shown in Fig-7 for which lateral stiffness is calculated as shown in Tables 2, 3 and 4 for parking, commercial and residential floor respectively. Lateral stiffness of parking floor (K_p) with height 3.96m $K_p = 3644514.5 \text{ kN/m}$

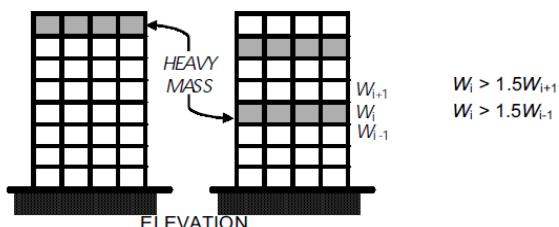
**Fig-8: Indication for Mass Irregularity**

Mass irregularity shall be considered to exist when the seismic weight of any floor is more than 150 % [2] and 200% [1] of that of the floors below respectively as shown in Fig-8.

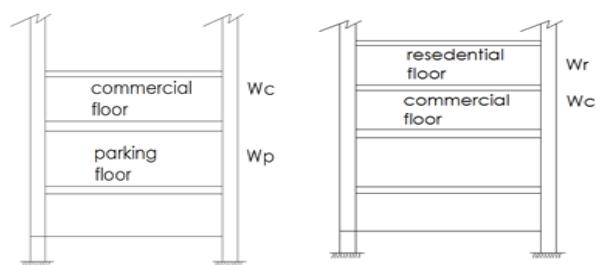
**Fig-9: Section of elevation indicating different types of floors**

Seismic weight is calculated for three different floors as shown in Fig-9 whose loads are different from one another and compared for the presence of mass irregularity.

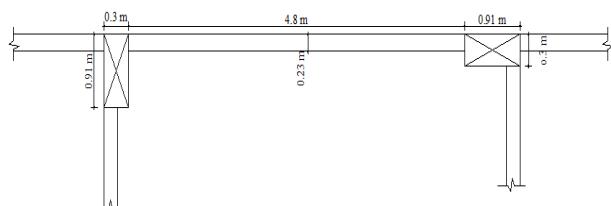
Fig-10: Portion of wall and column arrangement under consideration

A sample wall section was considered to check for the possibility of an equivalent diagonal strut as per Cl. 7.9 of IS 1893 (Part 1): 2016 as shown in Fig-10.

Clear length of wall = 4.8m
